Failure of a low rail in a curved railway track subject to long term rail-wheel interactive wear

Jiao, H & Wood, D 2014, 'Failure of a low rail in a curved railway track subject to long term rail-wheel interactive wear', in ST Smith (ed.), *23rd Australasian Conference on the Mechanics of Structures and Materials (ACMSM23)*, vol. I, Byron Bay, NSW, 9-12 December, Southern Cross University, Lismore, NSW, pp. 595-600. ISBN: 9780994152008.

FAILURE OF A LOW RAIL IN A CURVED RAILWAY TRACK SUBJECT TO LONG TERM RAIL-WHEEL INTERACTIVE WEAR

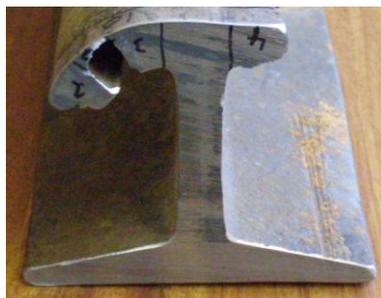
It can be seen from the rail sample shown in Figure 1 that the rail experienced severely worn on the railhead with a large amount of lateral plastic deformations and material loss.

Figure 1. A cross sectional view of the rail sample

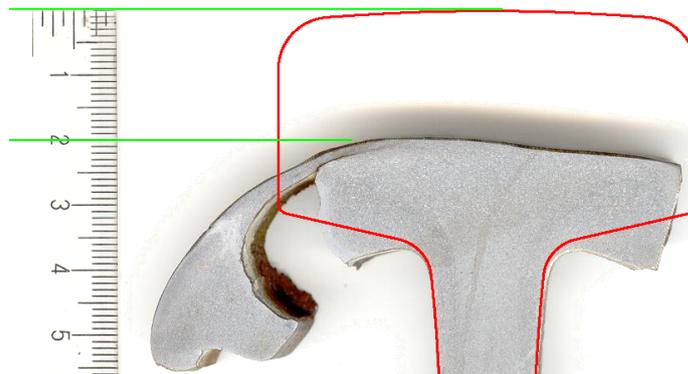
The deformed rail profile was compared with the undeformed rail sections as shown in Figure 2. The red line in Figure 2 shows the profile of a 80lb ASCE rail manufactured by HarmerSteel (2009). About 20mm thick rail material had been lost from the railhead due to plastic deformation and wear. The plastic flow was accompanied by a crack that caused the separation of a part of rail from the railhead. The crack appeared to be initialized in the horizontal direction in a location below the rail surface. It seemed that a part of the railhead was pushed away by a shear force generated by the plastic flow on the railhead. The geometrical profiles on both sides of the crack had similar profiles. A mushrooming shaped plastic deformation happened at the end of the railhead. The mushrooming type of deformation was regarded as a common type of rail degradation (Reddy et al. 2008).

In addition to plastic flow, flake-like wear debris was also observed on the surface of the railhead. This failure mode was called plastic ratcheting by Kapoor (1997). Franklin & Kapoor (2007) explained that ratcheting occurred due to the load exceeded the plastic shakedown limit of the rail, causing large plastic shear strains in the near surface of the railhead. Another observation is the trace on top of the railhead left by train wheels along the train running direction. The trace indicates that mixed traffic conditions (with different wheel dimensions) might have been running on the railway track. Mixed

Figure 2. Comparison between the deformed rail head and an undeformed rail

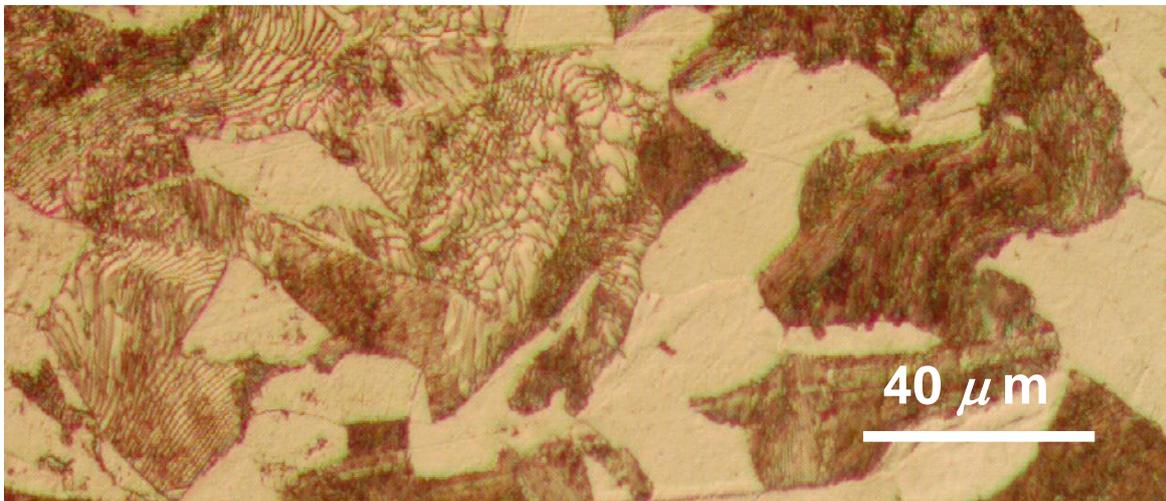
An Olympus BX40F4 optical microscope with 500x magnification was used for microscopy examination of the rail samples. Optical images were taken from samples at different locations with an increasing depths from the surface of the railhead. Figure 3 shows an image taken at 5mm below the rail surface. It can be seen from Figure 3 that clear pearlitic lamella microstructure is surround by proeutectoid ferrite. By contrast, severe plastic flow was observed near the railhead within about 2mm from the railhead surface. Grains in this region were severely distorted due to plastic flow in the lateral direction as shown in Figure 4 that was taken at a depth of 80 μm into the railhead. It can be seen that both proeutectoid ferrite and pearlite are severely deformed with grains being layered and reoriented along the lateral direction. The grains below the main crack are less deformed than the grains above the crack.

Figure 3. Pearlitic lamella structure with ferrite (light phase) and cementite (dark phase)

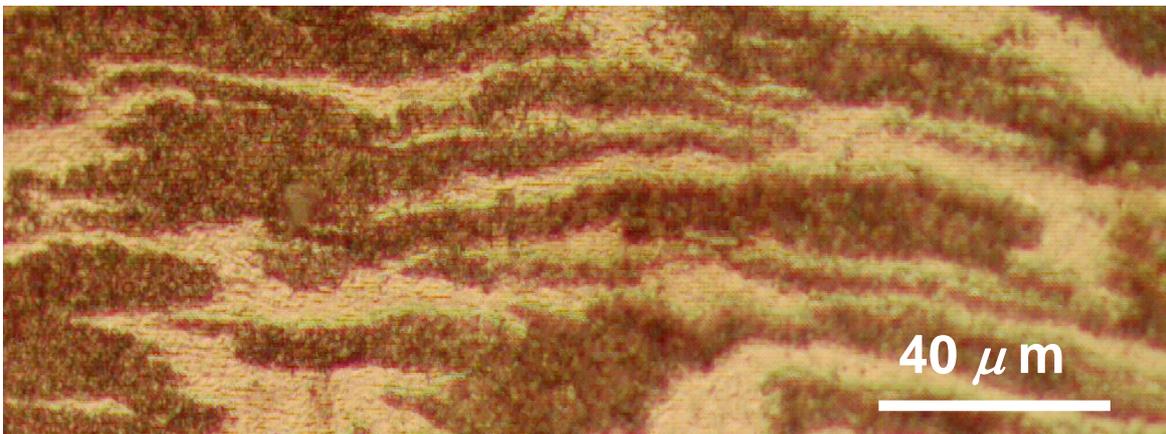
Figure 4. Heavily deformed proeutectoid ferrite and distorted pearlite structure (80 μm from the surface of the railhead)

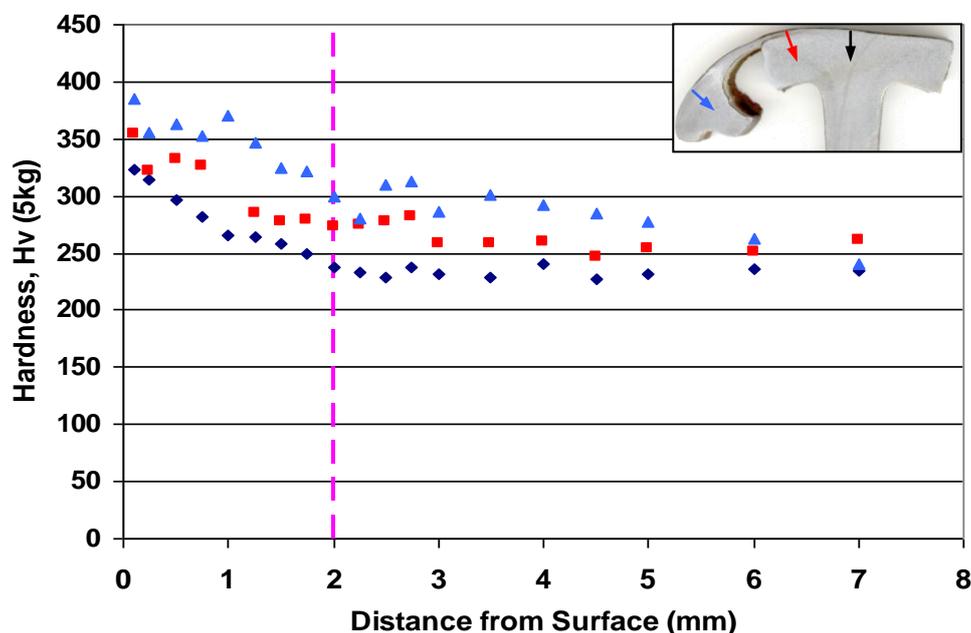
Vickers hardness tests were conducted on the rail sample from the centre to the side and from the surface to the inside of the railhead in accordance with AS1817.1 (2003). The HV hardness results are shown in Figure 5. A test force of 5kg was applied and hold for 10 second. The average diagonal length of indentations was 182 μm . It can be seen that the hardness was higher near the rail surface with HV values ranging from 320 to 385 due to the strain hardening. Variations in hardness measurements in certain locations were recorded, which may be due to the difference of hardness in ferrite and pearlite grains. It was found that the depth of strain hardened layers was about 2 mm, in which the hardness was decreased to the bulk material hardness (Average 261HV).

Figure 5. Hardness test results
